Docket No. 217 – Development and Management Plan Inspection

Northeast Utilities Service Company Certificate of Environmental Compatibility and Public Need for the construction of a 345-kV electric transmission line and reconstruction of an existing 115-kV electric transmission line between Connecticut Light and Power Company's Plumtree Substation in Bethel, through the towns of Redding, Weston, and Wilton, and to the Norwalk Substation in Norwalk, Connecticut.

Date: May 25, 2006

Location: Overhead Line (Composite 345kV and 115kV Gallows Hill to Archers Lane,
345kV H-Frame Hoyts Hill to Gallows Hill, and Norwalk Section)

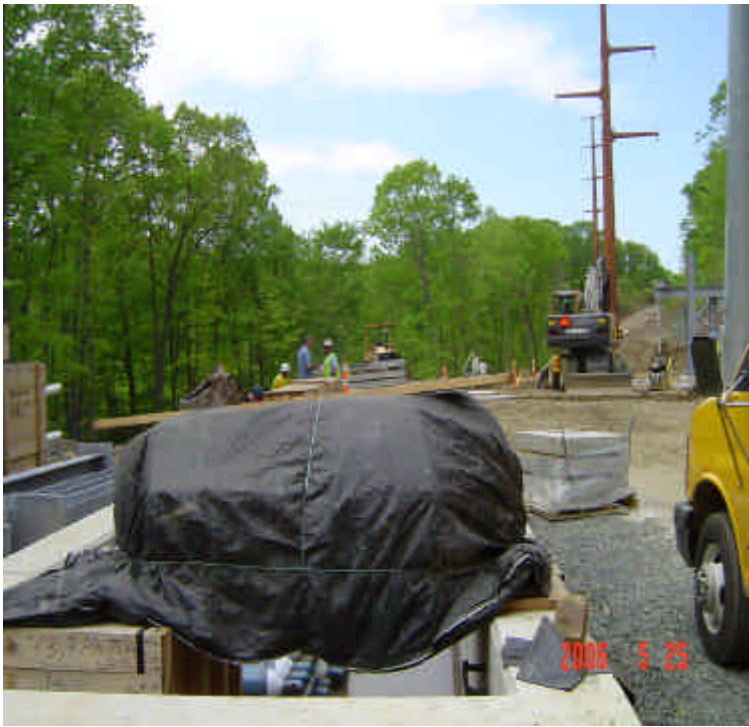
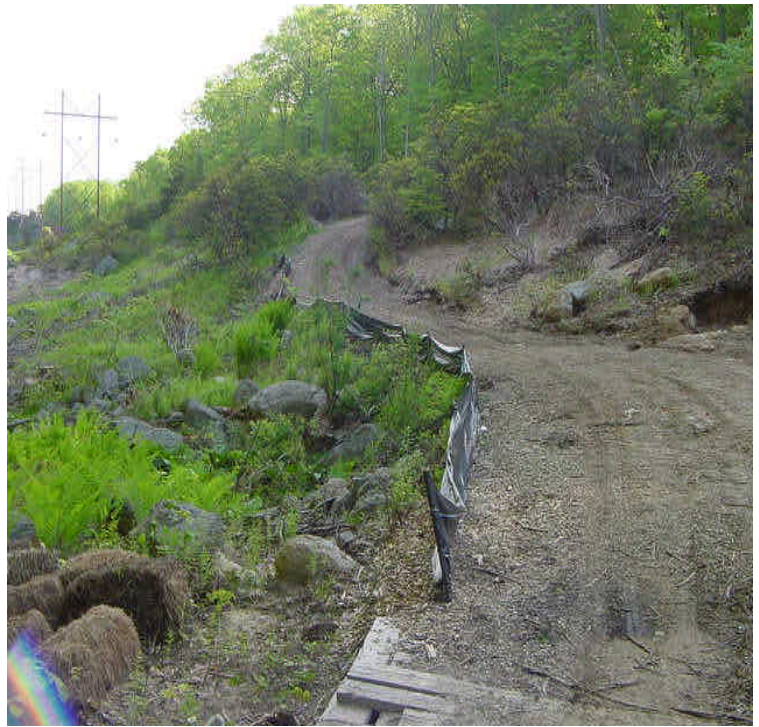
(Composite Section): Photo on the left shows the Archers Lane pad looking towards the ROW. The upper wire was installed along the poles here. (345kV H-Frame): Photo on the right shows the wetland crossing near structure #9 in good shape. 5/25/06

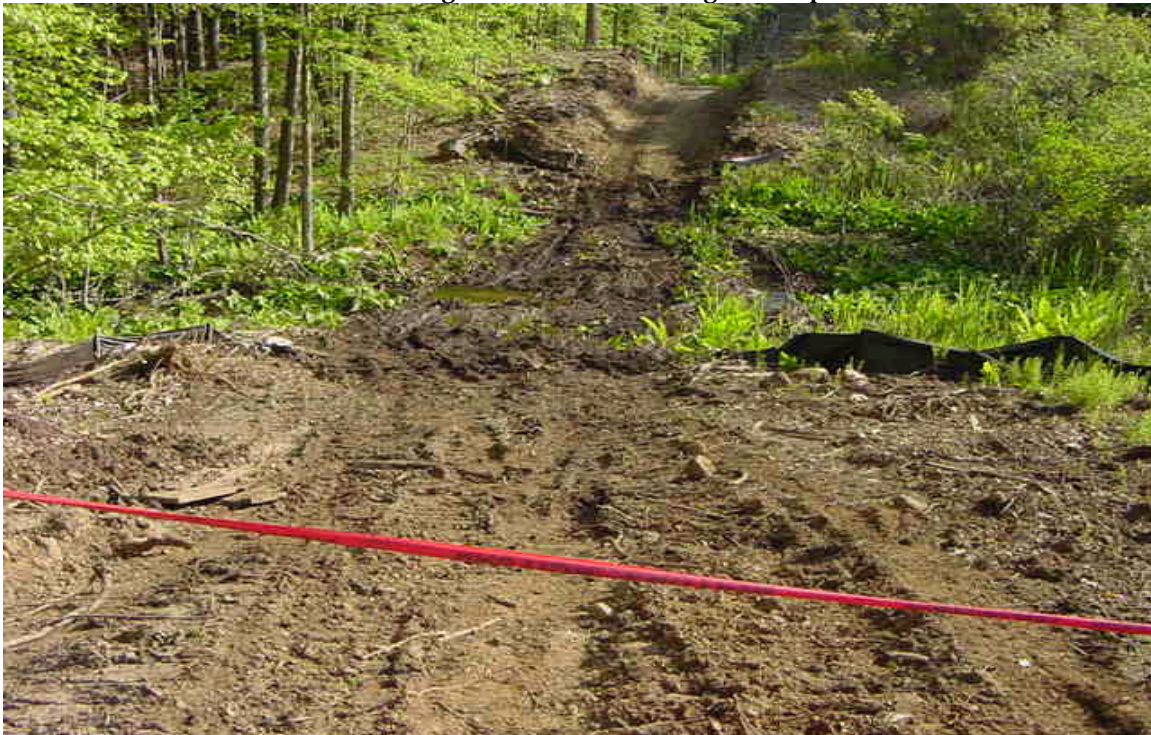
- All wetland crossings are still matted and in good shape. 5/25/06	- Continue to monitor. 5/25/06	-N/A
	- A vehicle accidentally drove through the wetland between poles #10-11 after mats were removed. Some ruts were created but the water main was not damaged. 5/25/06	- See erosion control section for more details but ruts should be smoothed out and additional controls installed. 5/25/06	- Needs attention

- A vehicle accidentally crossed the stream & wetland between poles #10-11. Some ruts were created in the wetland. 5/25/06	-Any ruts in the stream or wetland should be smoothed out. (No damage to the water main had occurred.)	- Needs attention
	Disturbed soil remained on the access road adjacent to the wetland. 5/17-5/25/06.	Additional controls should be placed across the ROW to prevent sedimentation. 5/17-5/25/06	- Needs attention
Costa Lane, Whortleberry, Lime Kiln and John Todd

(345kV H-Frame): Photo on the left shows a view of the wetland between structures #10 and 11 where a truck had accidentally driven through after mats were removed. Silt fence should be installed across the ROW on both ends and the surface restored where necessary. 5/25/06.

- A vehicle tracked through the wetland between #10-11. 5/25/06	- Ruts should be smoothed out and additional controls are needed. 5/25/06	-Needs attention
Norwalk Section	-Foundations being installed are adjacent to wetlands and waterbodies and most controls are in good shape. 5/25/06.	-Continue to monitor. 5/25/06.	-N/A.
All Sections	- Use caution in clearing trees from wetland areas. Avoid creating ruts when skidding them out. 3/29-5/25/06.	- Retain shrubs and low growth as much as possible, especially at stream buffers. 3/2-5/25/06.	- Needs some improvement in the new section even though only invasive species are present
	-If a wetland is being used as amphibian breeding habitat, retaining some wood debris at its boundaries may be beneficial. 3/2-5/25/06.	-Carefully remove brush piles and trees from near wetland areas. 3/2-5/25/06. - Watch this near the pool on the new ROW section in Wilton

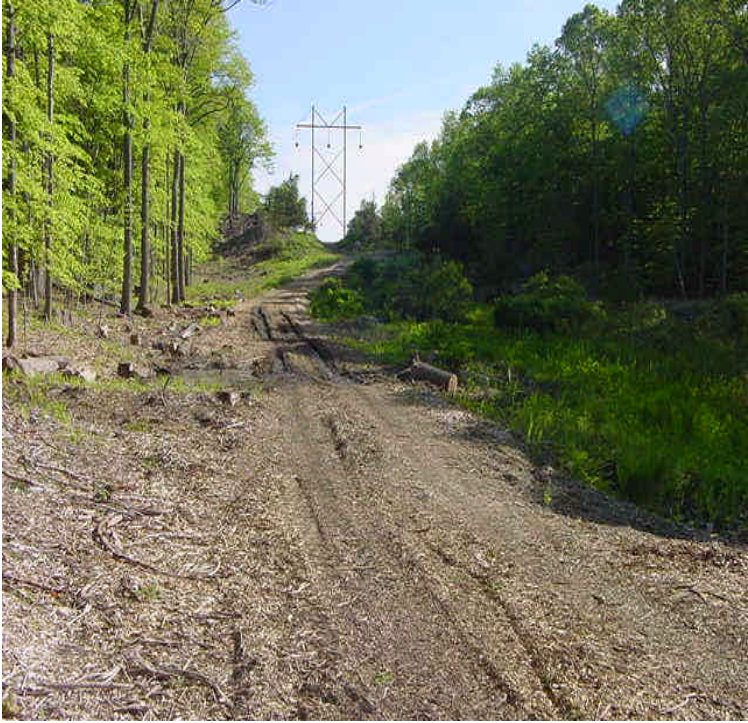
- Some ruts were noted in the access road between poles #5-6.	- More wood chips and some repair to the ruts may be necessary. 5/25/06	- Needs attention when feasible.

Photo on the left shows a view of the access road in the Chestnut Ridge Rd section between structures #5 and 6. Some ruts were noted here and they should be repaired. Photo on the right shows the wetland near structure #25 with controls remaining well in place. 5/25/06.

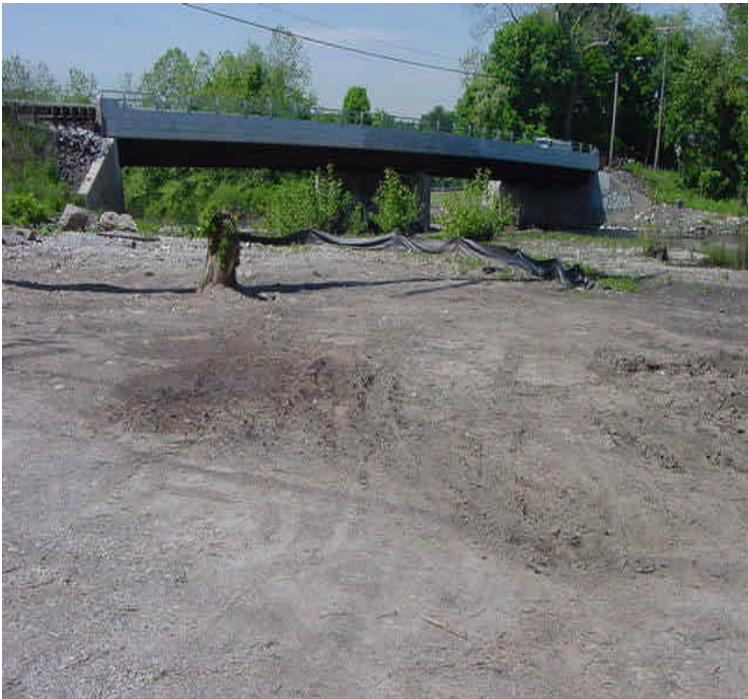
- The flooded silt fence north of Broad St was able to be restored. 5/25/06.	- Continue to maintain fence as needed. 5/25/06.	-Silt fence was repaired.

(Norwalk Section): Photo on the left shows the silt fence repaired by the structure just north of Broad St following the flooding. Photo on the right shows another area north of Broad St. where silt fence was also repaired. 5/25/06.

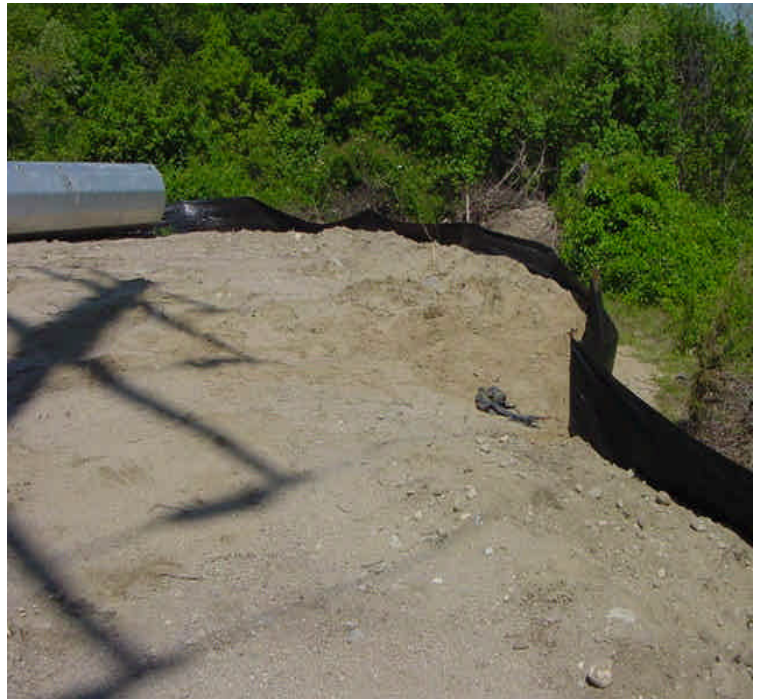
- The silt fence to the area further north near #11078 was also repaired. 5/25/06	-Continue to maintain. 5/25/06	-Silt fence was repaired.
	- The foundation near the Norwalk substation has good silt fence coverage. 5/17-5/25/06.	-Continue to monitor due to proximity of the river. Consider picking up adjacent debris left behind by the river. 5/25/06	-N/A

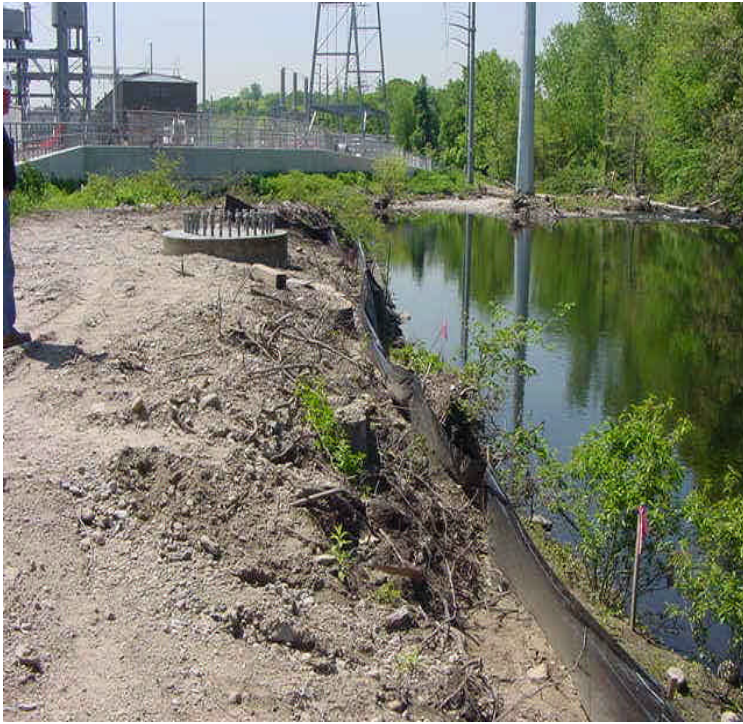
- The foundation adjacent to the Norwalk Sub was poured 5/25/06	-See erosion controls section for more information. 5/25/06.	-N/A
	- Structures installation and foundation work continues between Perry Ave. and the Rt 7 extension. (#11071 was being set at the time of inspection) 5/17-5/25/06.	- See erosion controls section for more information. 5/25/06.	- N/A

Photo on the left shows the foundation poured adjacent to the Norwalk Substation. Silt fence is in good shape here. Photo on the right shows the wires being pulled through the structures near the substation. 5/25/06.

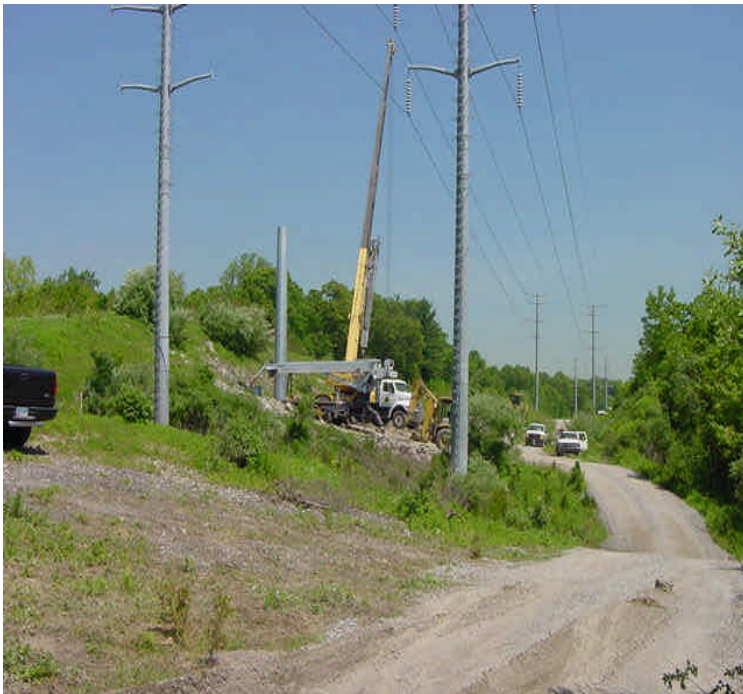
Photo on the left shows a structure being placed off Perry Ave. Photo on the right shows a wetland crossing near North Seir Hill Rd. Haybale or silt fence check dam should be placed at the corners. 5/25/06

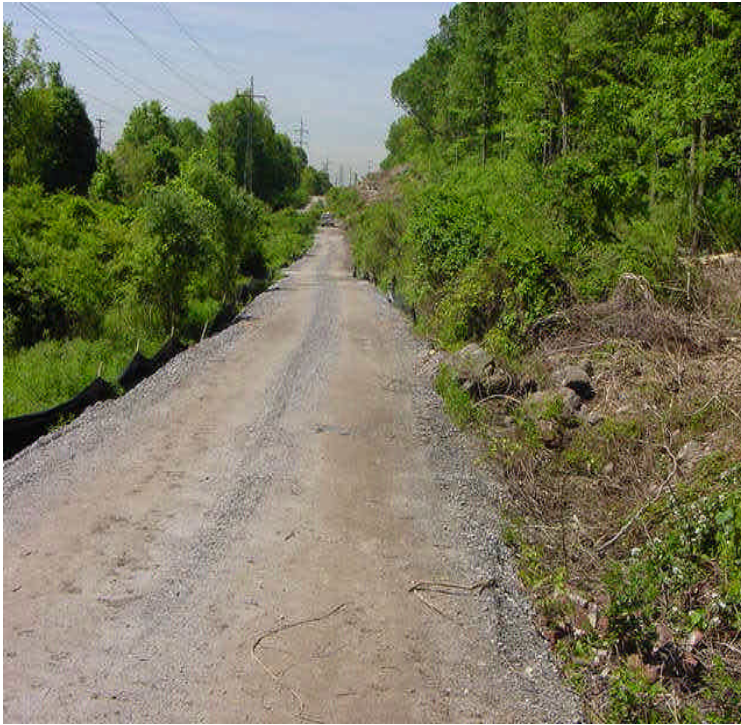
Photo on the left shows an access road within the ROW off Kent Rd. Silt fence was installed along the roadway. Photo on the right shows another matted wetland crossing in this area. Check dams were installed at the corners. 5/25/06

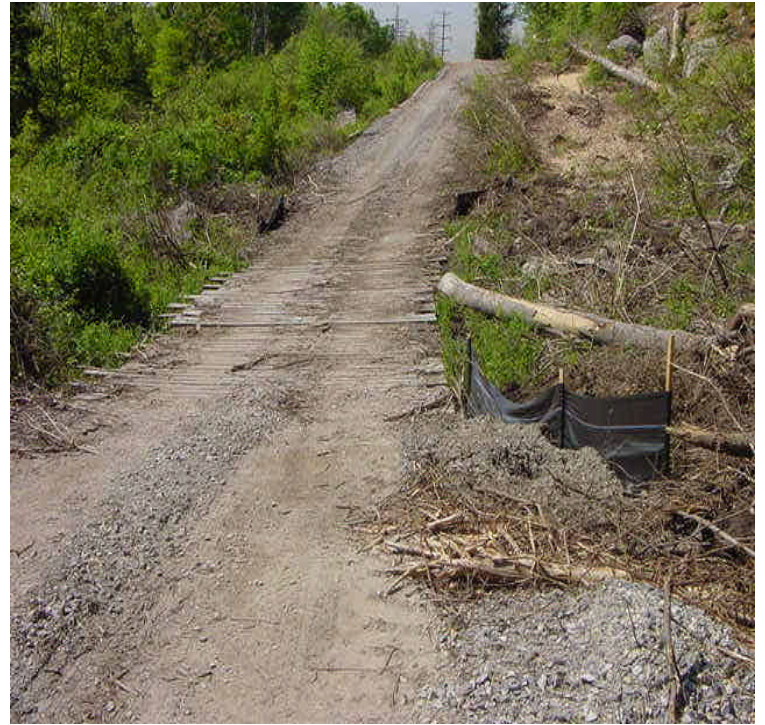
- Some of the wetland crossings in the Rt 7 ext-Kent Rd section now have controls at the mat corners. 5/25/06	- Continue to monitor. 5/25/06	- Controls were installed.

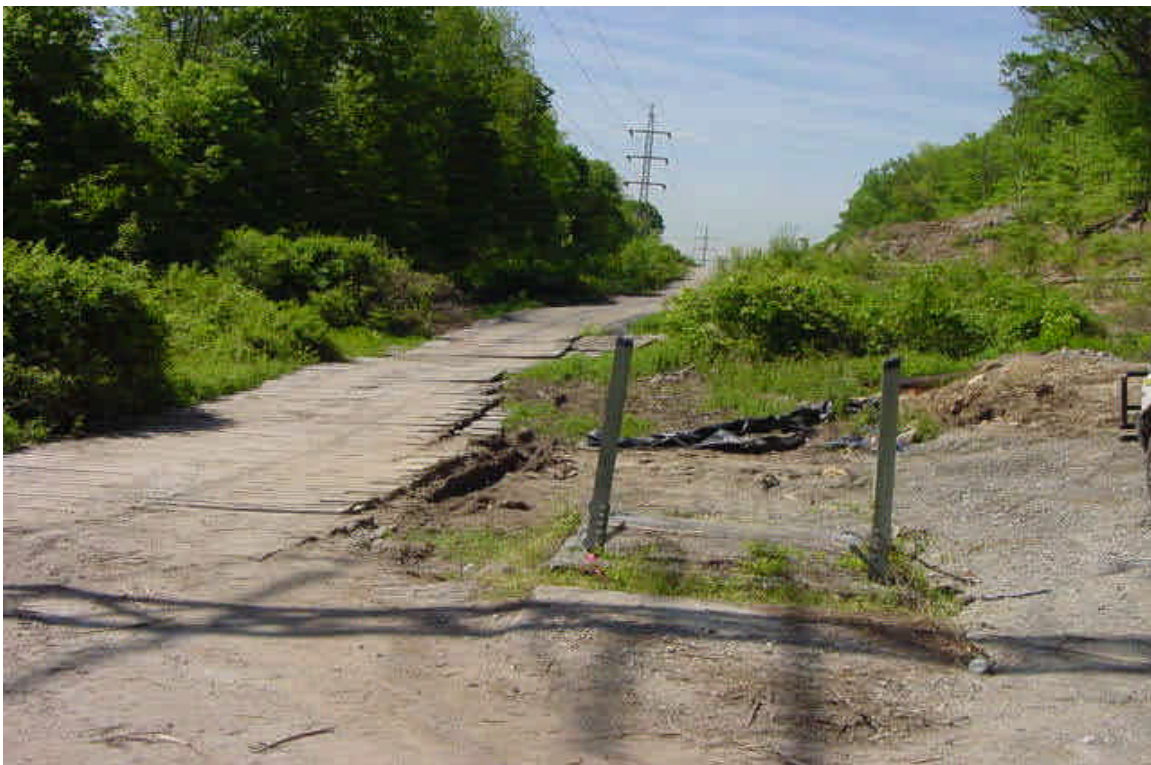
Photo shows another matted portion of the access road. An old tower foundation here will be removed at the end of the project. 5/25/06

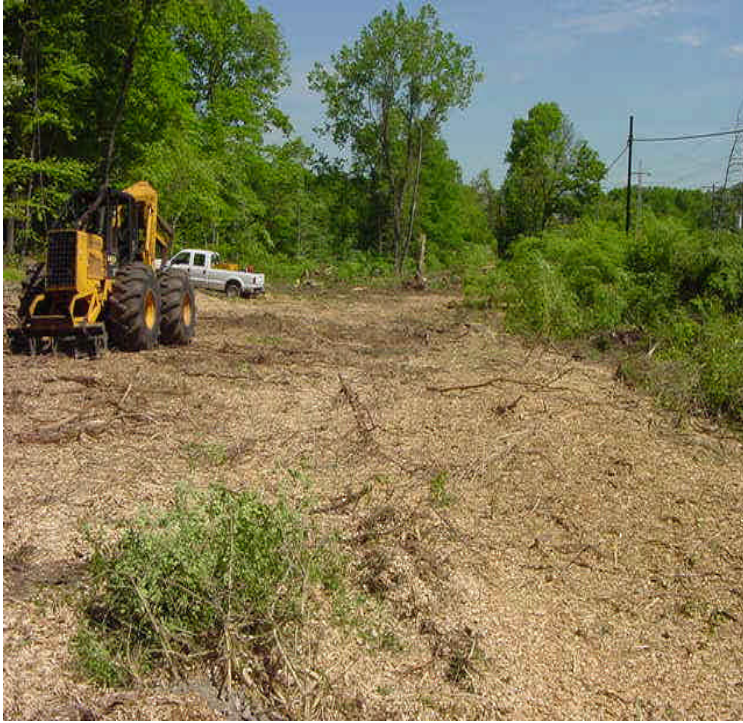
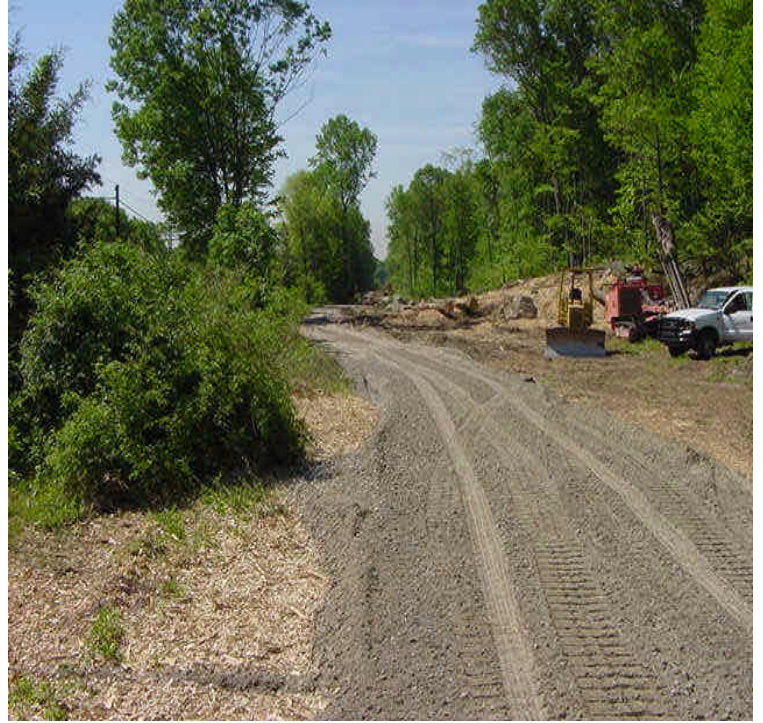
Photo on the left shows a view of the ongoing clearing work in the new portion of ROW off Kent Rd. Photo on the right shows a portion of the newly installed dust access road. 5/25/06

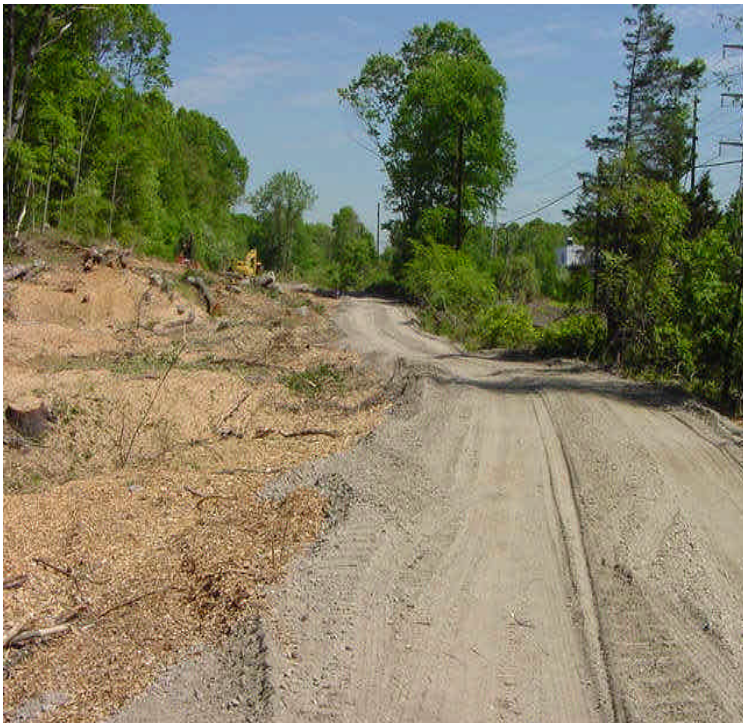
Photo on the left shows another view of the new access road and clearing. Photo on the right shows where clearing is occurring adjacent to a swale that enters a wetland area. Erosion controls should be installed to prevent any run-off. 5/25/06

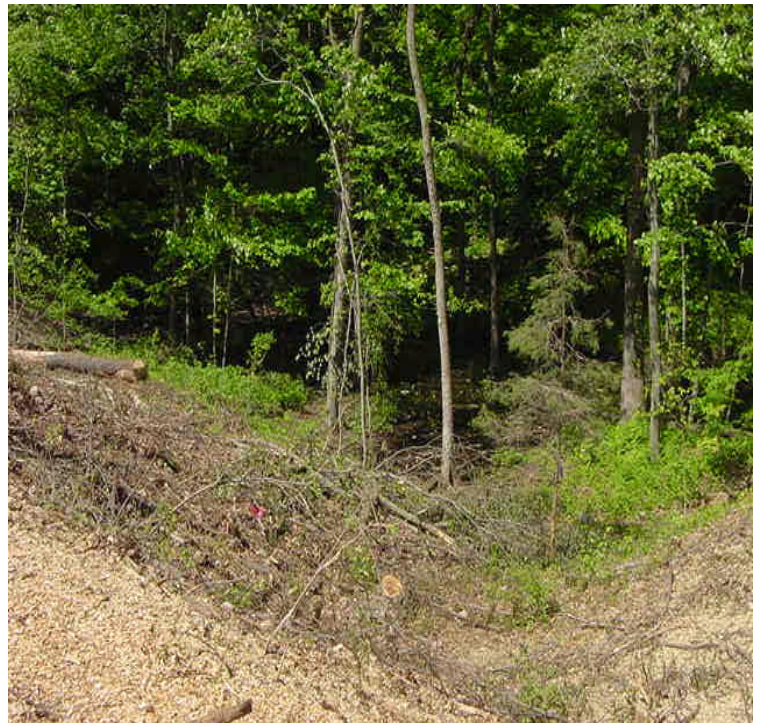
Areas of Inspection	Observation	Recommended Action	Corrective Action
	- A swale leading into a wetland area in the new, cleared portion of the ROW near Kent Rd. was noted. 5/25/06	- Install erosion controls along the tree line to prevent run-off to the wetland. 5/25/06	-Needs attention when feasible.
Inland Wetland and Watercourse encroachment and mitigation	-The D&M plan approved stone on geotextile fabric at the wetland crossings have worked well. 4/6-5/25/06.	- As the access is considered temporary, the stone will be removed when final work ends so the wetlands can be restored. 1/26-5/25/06.	-N/A until evaluated at the end of work.
Composite	- Direct damage was noted in the wetland at the 3 rd crossing as a result of equipment slipping. 2/16-5/25/06.	- The damage to the 3 rd wetland should be repaired if feasible but it may be more damaging to go in at this time. 5/4-5/25/06.	-N/A
345kV H-Frame	- At structure #6, most of the mud was removed from the wetland and they will continue to do so. 4/6-5/25/06.	- Continue to remove entire pile. 2/16-5/25/06.	-Needs attention when feasible.
